ROCKY MOUNTAIN ARSENAL

FINAL PHASE I
CONTAMINATION ASSESSMENT REPORT
SITE 36-3: INSECTICIDE PIT
(Version 3.3)

June 1987
Contract Number DAAK11-84-D0016
Task Number 1 (Section 36)

ENVIRONMENTAL SCIENCE AND ENGINEERING, INC.

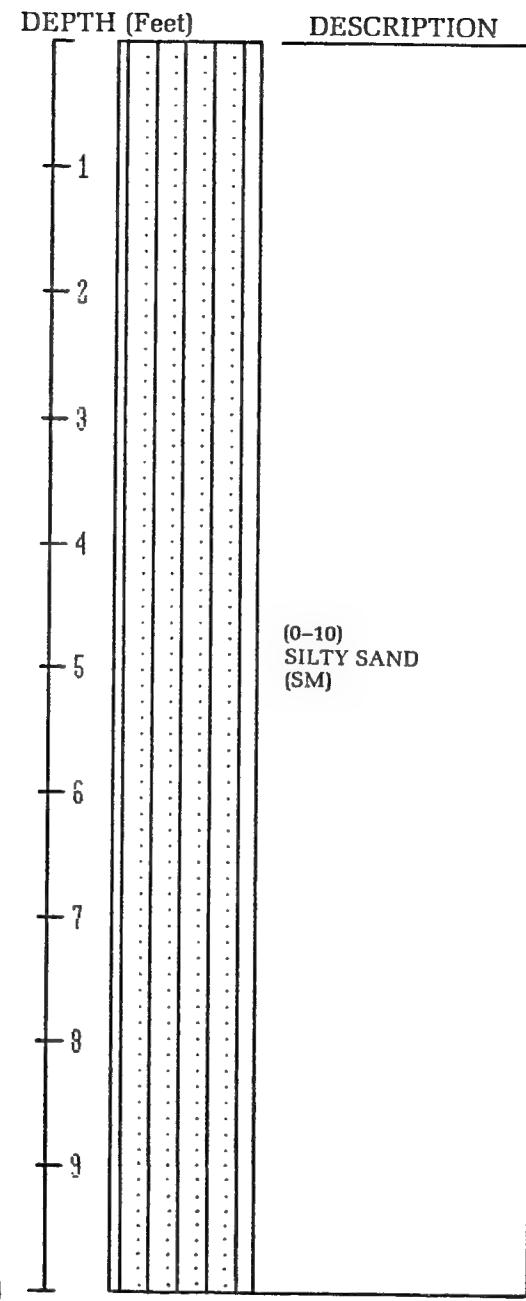
Figure 36-3-2
FIELD BORING PROFILE FOR BORING 3176

The results of the Phase I boring program confirmed that Site 36-3 is underlain by alluvial material consisting of silty sand. The depth of the Phase I borings was not adequate to determine the depth of the alluvial clay layer that underlies the silty sand. A thin surface layer of 1.8 ft of sandy silt was encountered at Boring 3179. Representative boring logs taken from Borings 3176 and 3178 are presented in Figures 36-3-2 and 36-3-3.

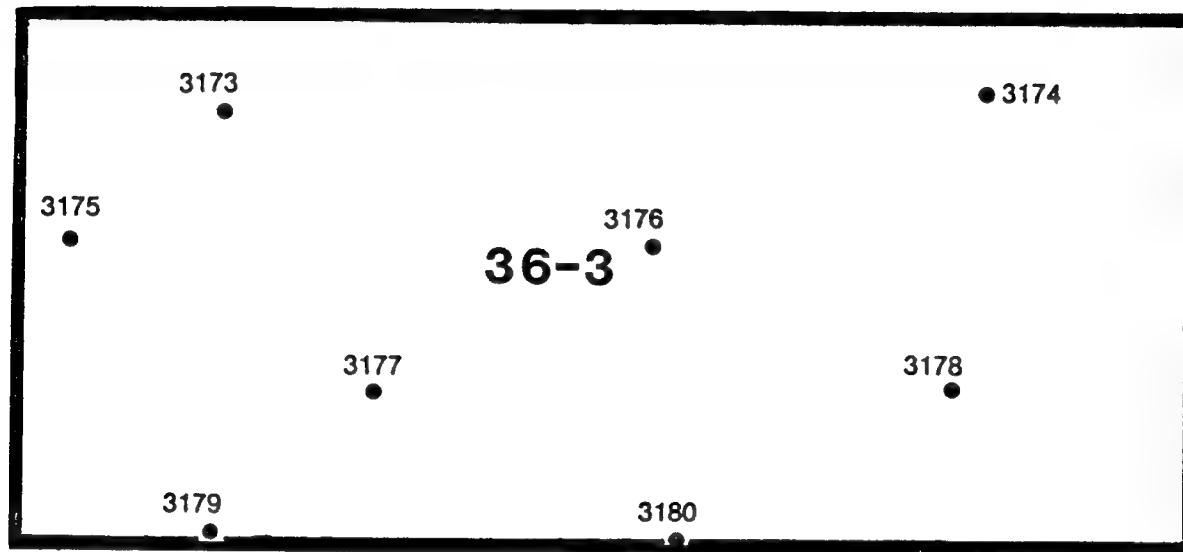
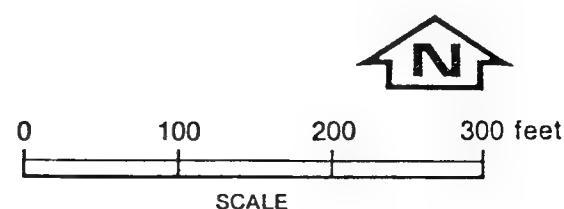
Figure 36-3-6
PHASE I INVESTIGATION,
BORING LOCATION MAP,
SITE 36-3
SOURCE: ESE, 1985

Based on an areal extent of 230,000 ft², the Phase I investigation consisted of eight borings. These borings were arranged in a grid pattern as shown in Figure 36-3-6. Borings ranged in depth from 3 to 10 ft. The site boundaries shown in Figure 36-3-6 differ from those presented in the Task 1 Technical Plan (ESE, 1985, RIC#85127R07) as a result of modifications made following field reconnaissance and aerial photograph interpretations to better locate sample points with respect to the actual landfill area.

On the basis of the geophysics program results, three borings (3176, 3178, 3179) had to be relocated due to possible buried metal. The contour plots of these borings all exhibited anomalies indicative of buried metal. The contour plots for Borings 3173, 3174, and 3180 also exhibited anomalies representative of potential buried metal, although these anomalies were positioned in a manner that did not require relocation of the borings. An anomaly present in the northwest corner of Boring 3173 grid was indicative of a large buried metal object relatively close to the surface. Metal detector scans of all boring locations in this site were negative for shallow (0 to 2 ft) metal.

- o Boring 3174 was halted at a depth of 3 ft when a large impenetrable object was encountered. Areas within 5 ft of the drill rig were noticeably shaken when the auger hit the object.

- o Trench debris was encountered at Boring 3178, including rubber gloves, cardboard, and paper. Sampling at this boring indicated that the depth to the bottom of the trench was approximately 9 ft.

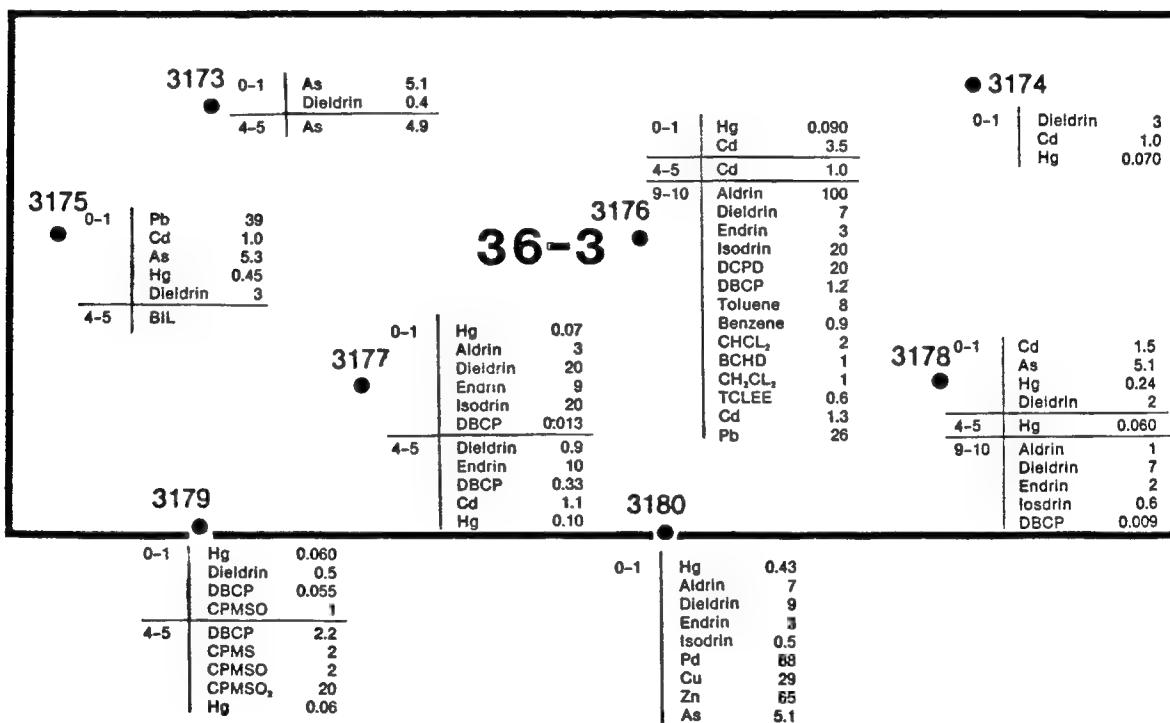
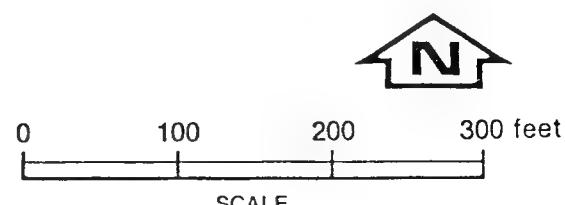
Figure 36-3-7
**PHASE I INVESTIGATION,
 CHEMICAL ANALYSIS
 RESULTS, SITE 36-3**

Phase I analytical results for Site 36-3 are consistent with the disposal history for this area. Each of the eight borings contained detectable concentrations of one or more organochlorine pesticides, including aldrin, dieldrin, endrin, and isodrin. Dieldrin is the most frequently observed organochlorine pesticide and the only one detected in five of the seven surface samples containing organic compounds. Concentrations ranged from 0.4 to 20 ppm in these samples. DBCP was observed in samples from four borings. The organosulfur compounds chlorophenylmethyl sulfide (CPMS), chlorophenylmethyl sulfoxide (CPMSO), and chlorophenylmethyl sulfone (CPMSO₂) were detected in Boring 3179, and dicyclopentadiene (DCPD) was also observed in only one boring (3176). Volatile organic compounds were analyzed in samples collected from the deepest intervals of Borings 3176 and 3178. One of these samples contained detectable concentrations of chloroform (CHCl₃, 2 ppm), methylene chloride (CH₂CL₂, 1 ppm), tetrachloroethene (TLCEE, 0.6 ppm), toluene (8 ppm), and benzene

Arsenic was present in Borings 3173, 3175, 3178, and 3180. With the exception of Boring 3173, all of these detections occurred in the 0- to 1-ft interval. All of the concentrations are within the indicator range and range from 4.9 to 5.3 ppm. Mercury was detected in 10 of the 16 samples. Seven of the concentrations were within the indicator range and three exceeded it. Six concentrations of cadmium were within the indicator range and one exceeded the range. Copper and zinc were found within their respective indicator ranges only in Boring 3180. Lead concentrations were within the indicator range in Boring 3175 (39 ppm) and Boring 3176 (26 ppm). The lead concentration (68 ppm) in Boring 3180 exceeded the indicator range. Appendix 36-3-A includes a list of target compounds and their associated abbreviations.
